Defects in chord to spudcan connections, Noble Intrepid

Riggvedlikehold 26. Sept 2024

Noble Intrepid

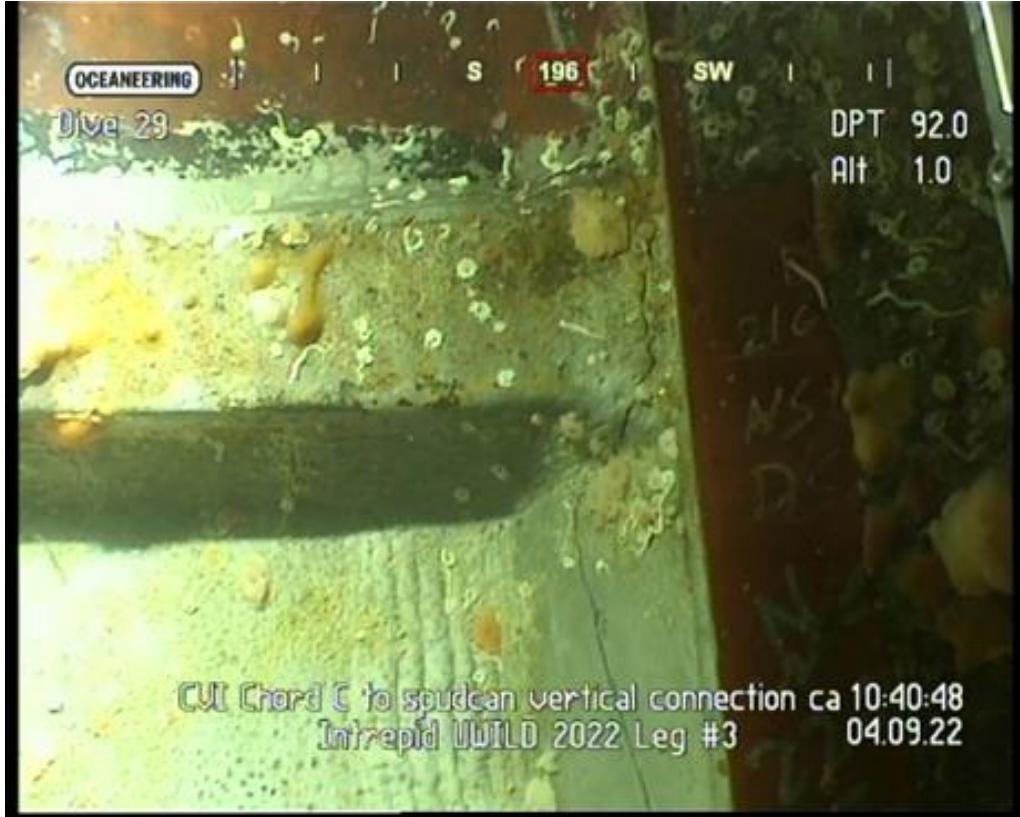
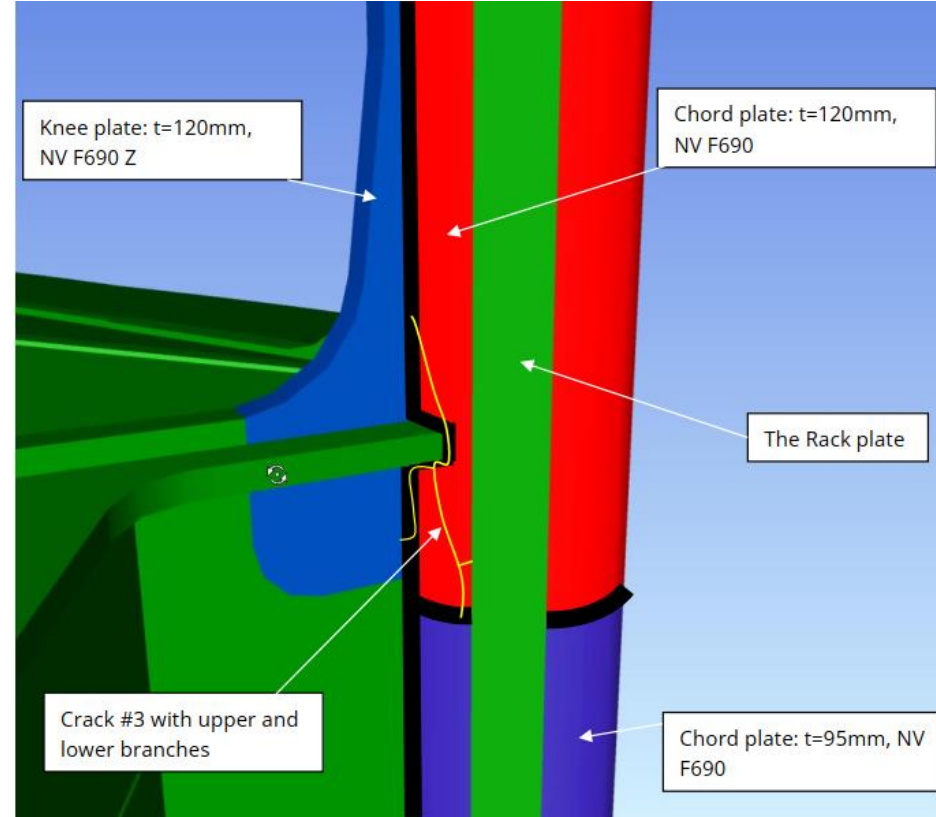
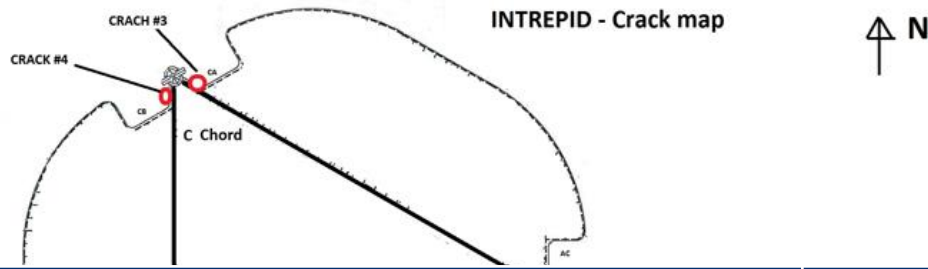
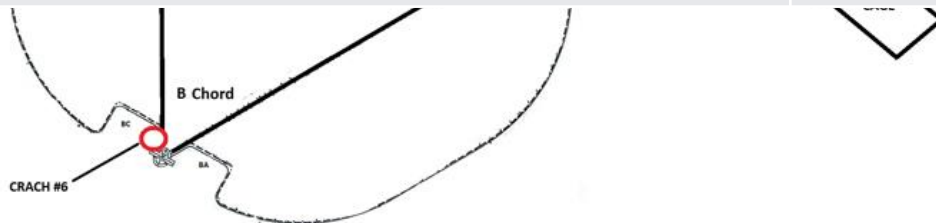
Crack #	Length
Crack #1	220 mm
Crack #2	350 mm
Crack #3	200 mm
Crack #4	140 mm
Crack #5	1000 mm
Crack #6	450 mm

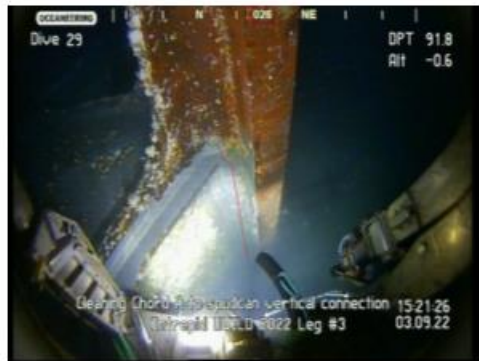
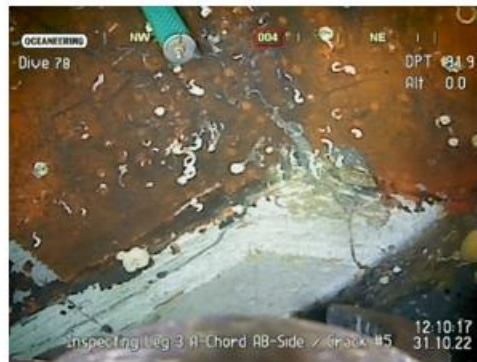
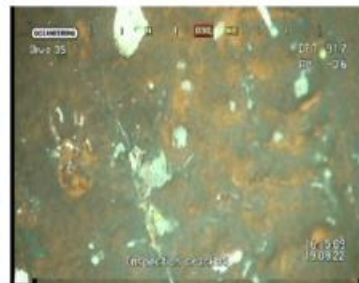
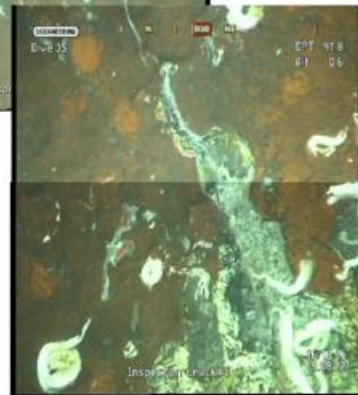
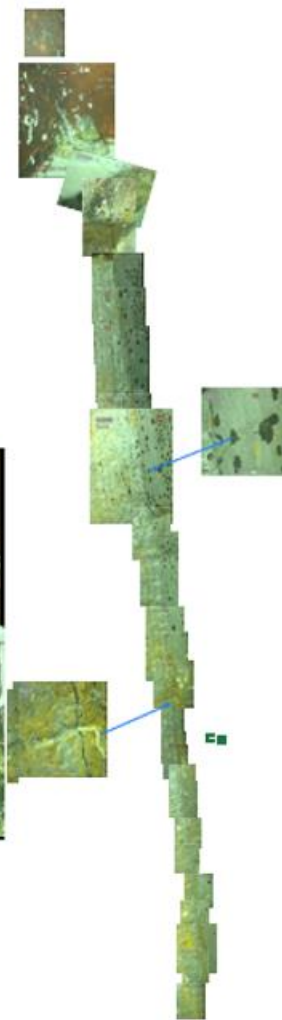
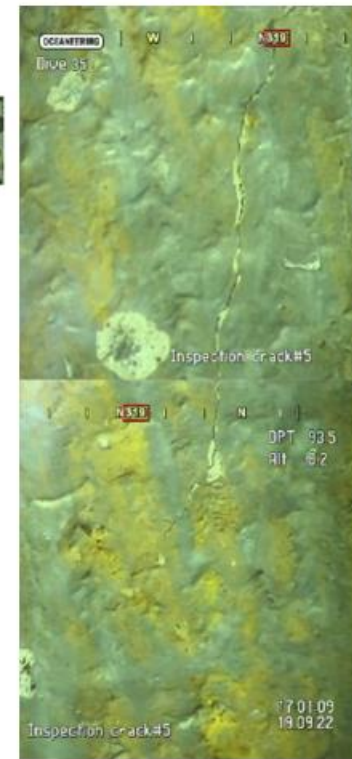
Indication #5, Leg 3, chord A, A/B side

- Mobilisation of UT subsea crew to confirm indications to be cracks in metal beneath coating
- Crack depth measurements of up to 91 mm but no water in chord
- Periodic visual ROV inspections to confirm no crack propagation
- Root cause analysis
- The failure mechanism causing the observed cracks is hydrogen assistant stress cracking – not hydrogen embrittlement. The cracks will not propagate fast.
- Prove remaining structural strength to continue operation
- Removal of anodes from Spud can (hydrogen point source)

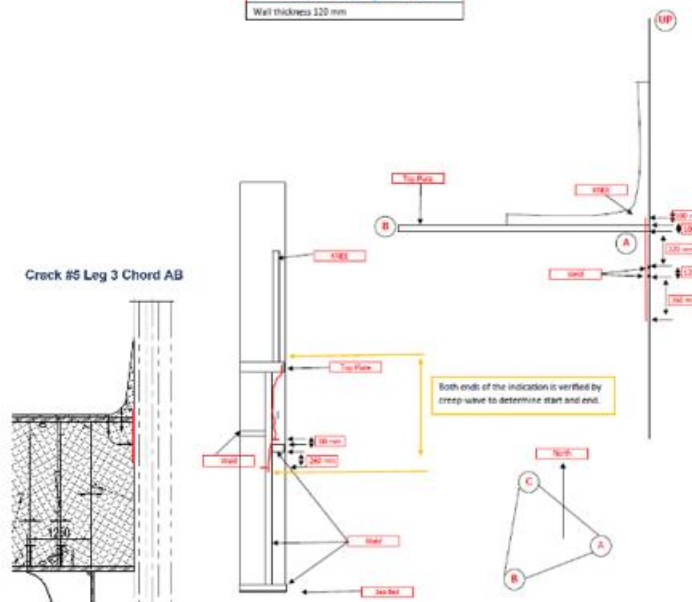
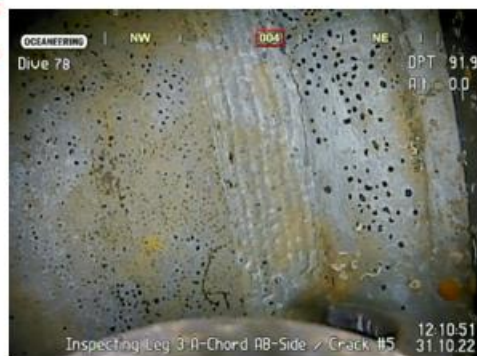
Crack #5 Leg 3 Chord AB

Leg #3 A-B Crack 5

Length of crack in mm	From 100 mm up from top plate + 100 mm top plate	To 860 mm below top plate
Maximum depth of crack in mm	83 mm	
UT highest point marked with blue	Length -	Depth 83 mm
Lowest reading with UT		
Wall thickness 120 mm

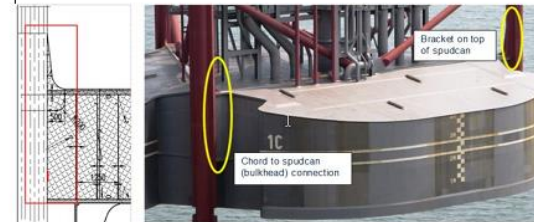
During INTREPID UWILD ROV inspection on September 2022, cracks were discovered on Spudcan to Leg Chord structure. In total 6 cracks have been observed spreaded on three legs. The cracks are inspected by ROV twice a week to check if they are propagating. From the beginning of September to early October no extension of the cracks have been noticed. The rig designer GustoMSC prepared a analysis of residual strength of the Intrepid footing to check if the rig can continue operation for the current location and site specific conditions. The FE-model analysis showed that the spudcan structure has sufficient remaining strength for the site-specific conditions even with cracks developed to longer length than in current view. Probable cause of the cracks is "hydrogen induced stress cracking".

- Develop Noble Bulletin IB-2020-10-12 for offshore inspection
- Inspection method: Close Visual

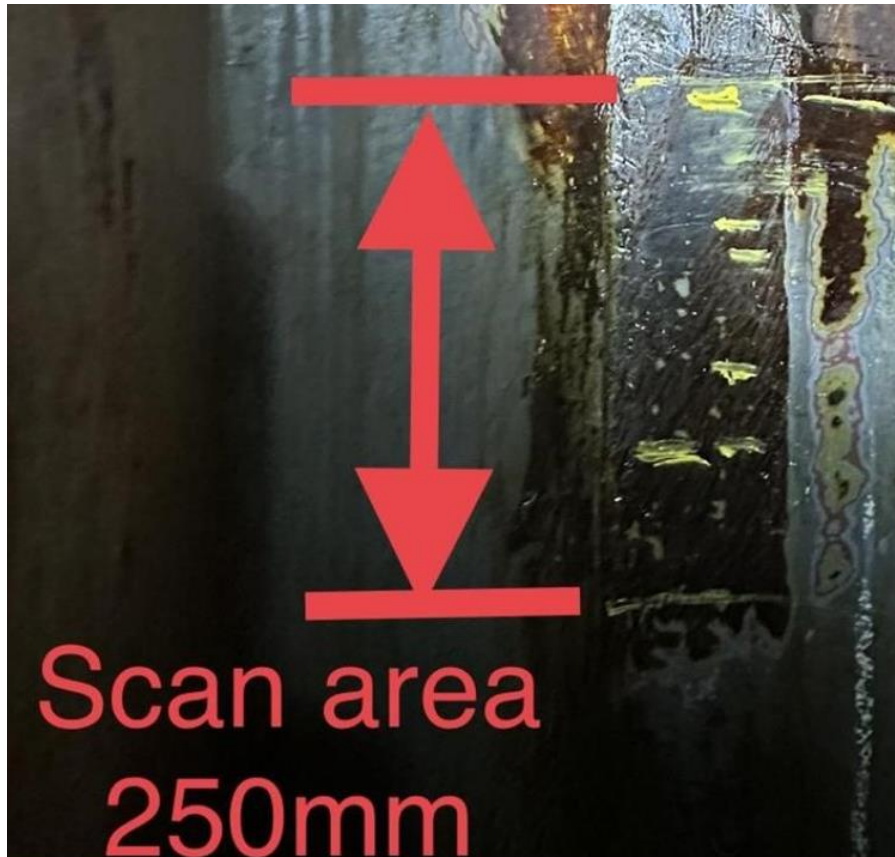
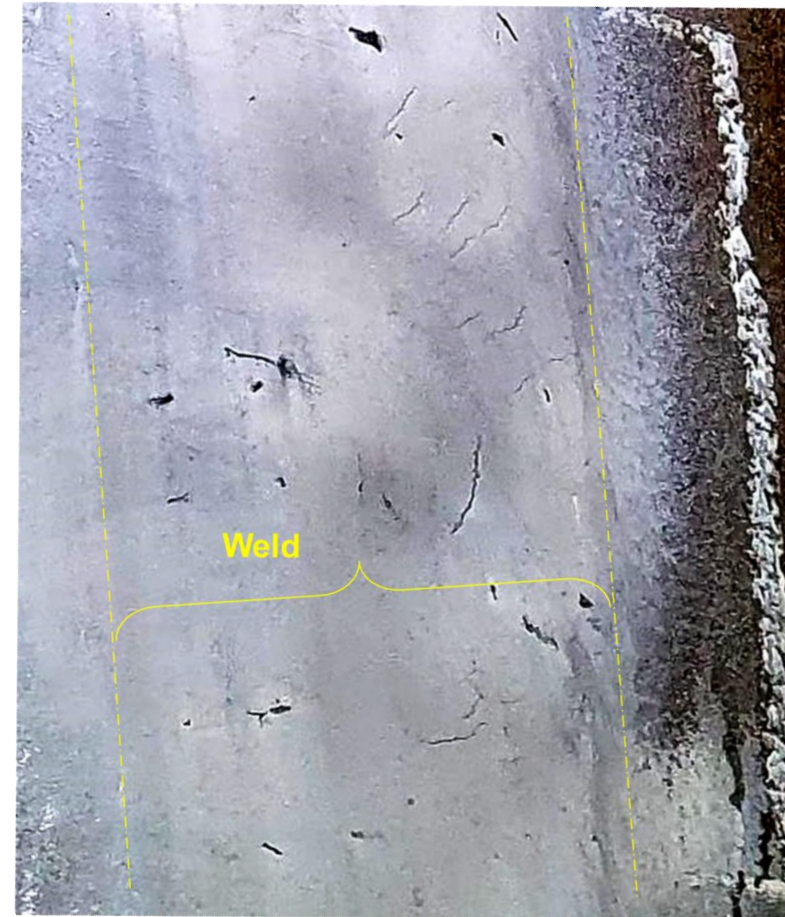
Intrepid – Transverse cracks

The UT inspection for transverse cracks revealed a number of subsurface transverse cracks in the vertical chord to spudcan welds.

- All surface breaking cracks removed by gauging and re-welded.
- All external chord to spudcan welds including bucket plate both sides removed by gauging and re-welded.
- Internal chord to spudcan welds in 12 locations (out of 18) removed by gauging and re-welded
- Topplate to bulkhead weld replaced over approx. 1.5 meter at 7 locations (out of 36).
- All gauging and welding work performed with a pre-heat temperature of 150°C. After completion of the welding work the area was heat treated with a temperature of 250°C for 48 hours.

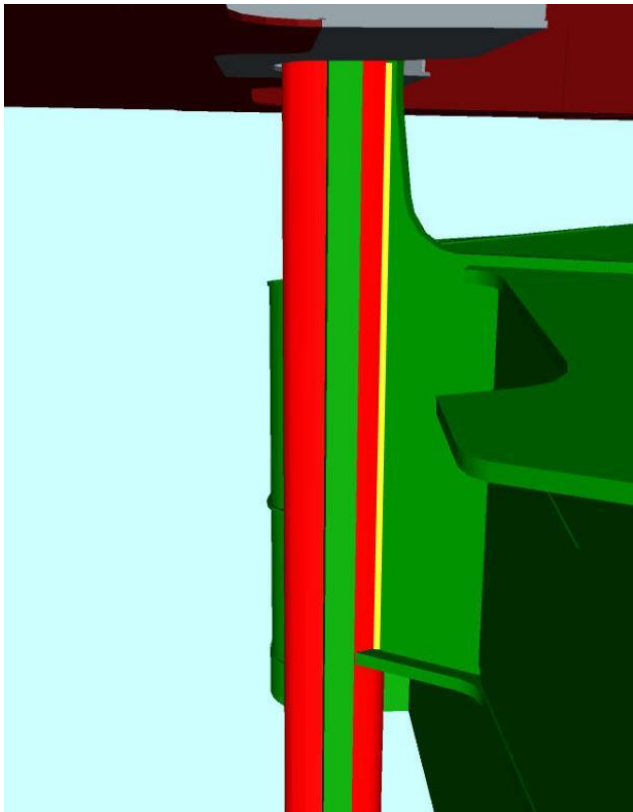
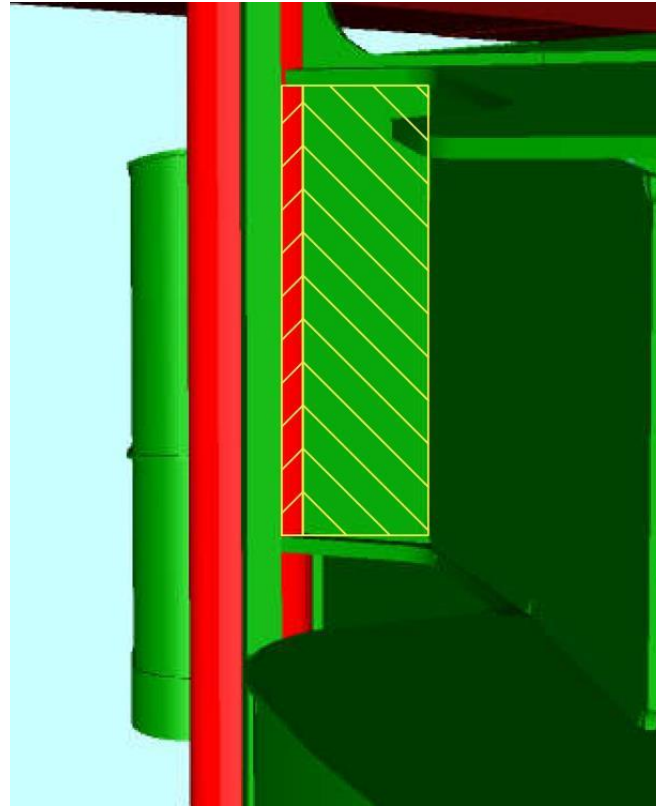
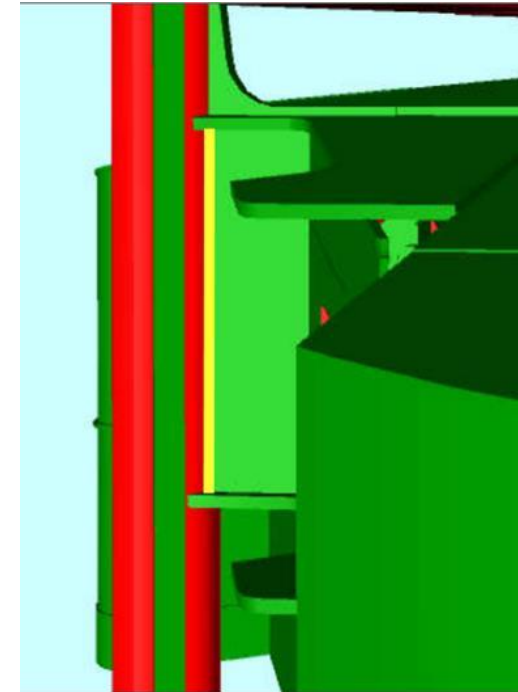
The experienced cracking problem is service related propagation of possible fabrication related flaws and defects.

The crack positions, paths and appearances indicate that

the welding process is the "provider" (root cause)

hydrogen uptake is the "trigger", (cathodic protection)

structural stress is the "driver". (wave, sea current, wind, gravitation load)

- 1) Visual inspection of the vertical external chord to spudcan weld including both side of the knee plate. All legs/all chords. Yearly.
- 2) Inspection for any coating breakdown in the chord to spudcan weld area. All legs/all chords. Yearly.
- 3) PAUT inspection of the vertical external chord to spudcan weld. Total 6 locations. 2.5 yearly (UWILD/SPS).
